The wreck of the *Highland Fling*: tragedy and ballast at sea

Paul Blickle

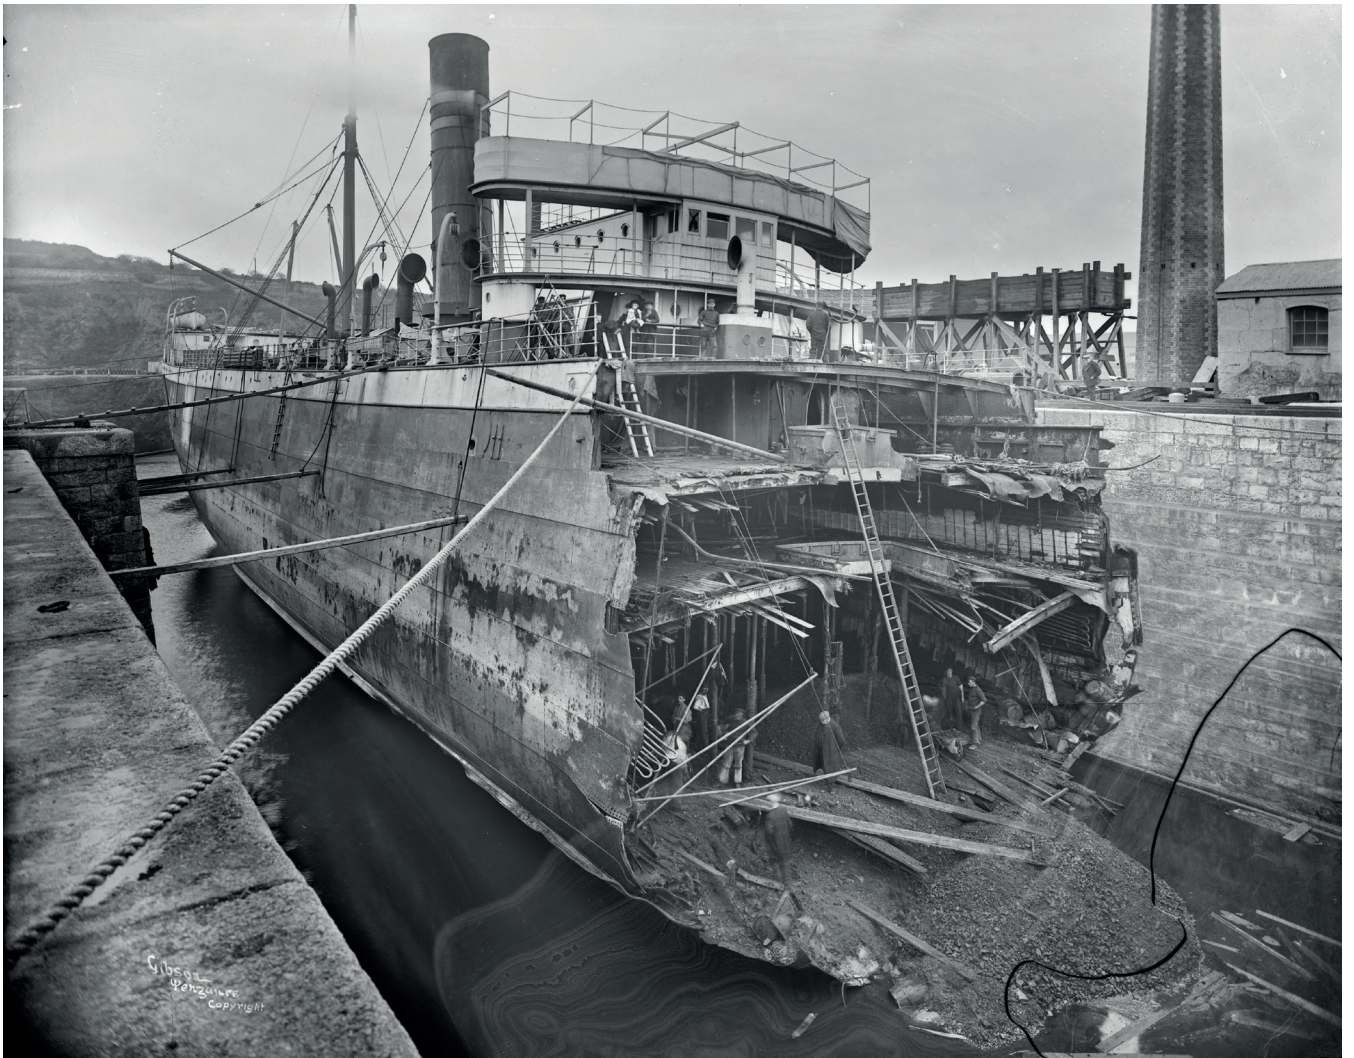
Fig. 01
Port side view of 'Highland Fling' (1889), from the break in the hull, looking aft along dock. People can be seen in the cross-section of the hull. Credit line: © National Maritime Museum, Greenwich, London, Gibson's of Scilly Shipwreck Collection Object: G14156 Artist: Gibson's of Scilly Shipwreck Collection Date: unknown Medium: glass negative Size: 254 mm x 305 mm

in 1907.¹ A terrible disaster has sundered the ship in half, and all that remains is an almost anatomical cross-section of the ship. Labourers are interrupting their work to pose for the photographer. They are in the process of clearing ballast from the ship's hold before its engines and parts can be salvaged and the rest of the *Highland Fling* scrapped.

This photograph of a shattered hull hides a rare sight. It is not the shipwreck. The ship in question is the British steamer *Highland Fling* and the picture was taken at the Falmouth drydocks early

Tragic as it was, the fate of the *Highland Fling* was by no means unusual. Surviving images of the shattered ship bear witness to the dangers of seafaring even at the dawn of the twentieth century. The dimensions of the remaining half of the hull are impressive, dwarfing the men labouring in its shadow, yet the advances of the industrial age were no match for the violence of wind and sea. Yet the apparent catastrophe of the shattered *Highland Fling* conceals something as mundane as it is invisible. Strwn across the lowest point of the hull lie sand and rocks, which the labourers are slowly removing by means of their shovels and wheelbarrows.

Another interesting aspect of the photographs is that the cross-section shows neither a double bottom nor double hull. Towards the end of the nineteenth century, many ships had adopted double hulls, which made them more durable. The space in-between was waterproofed and used as a tank that could be filled with seawater. Water is less dense than sand and stone, but

Not all water ballast was kept in double hulls. On board the *Highland Fling*, the water was most likely carried in large tanks located at the bow and stern of the ship and is therefore not visible in the cross-section. While it is often argued that solid ballast, like sand and stone, was quickly replaced by water, the images of the *Highland Fling* demonstrate the persistence of solid ballast. At the turn of the century, most steamers still used a mixture of water and solid ballasts, as well as the weight of their fuel, to stabilise the ship.⁹

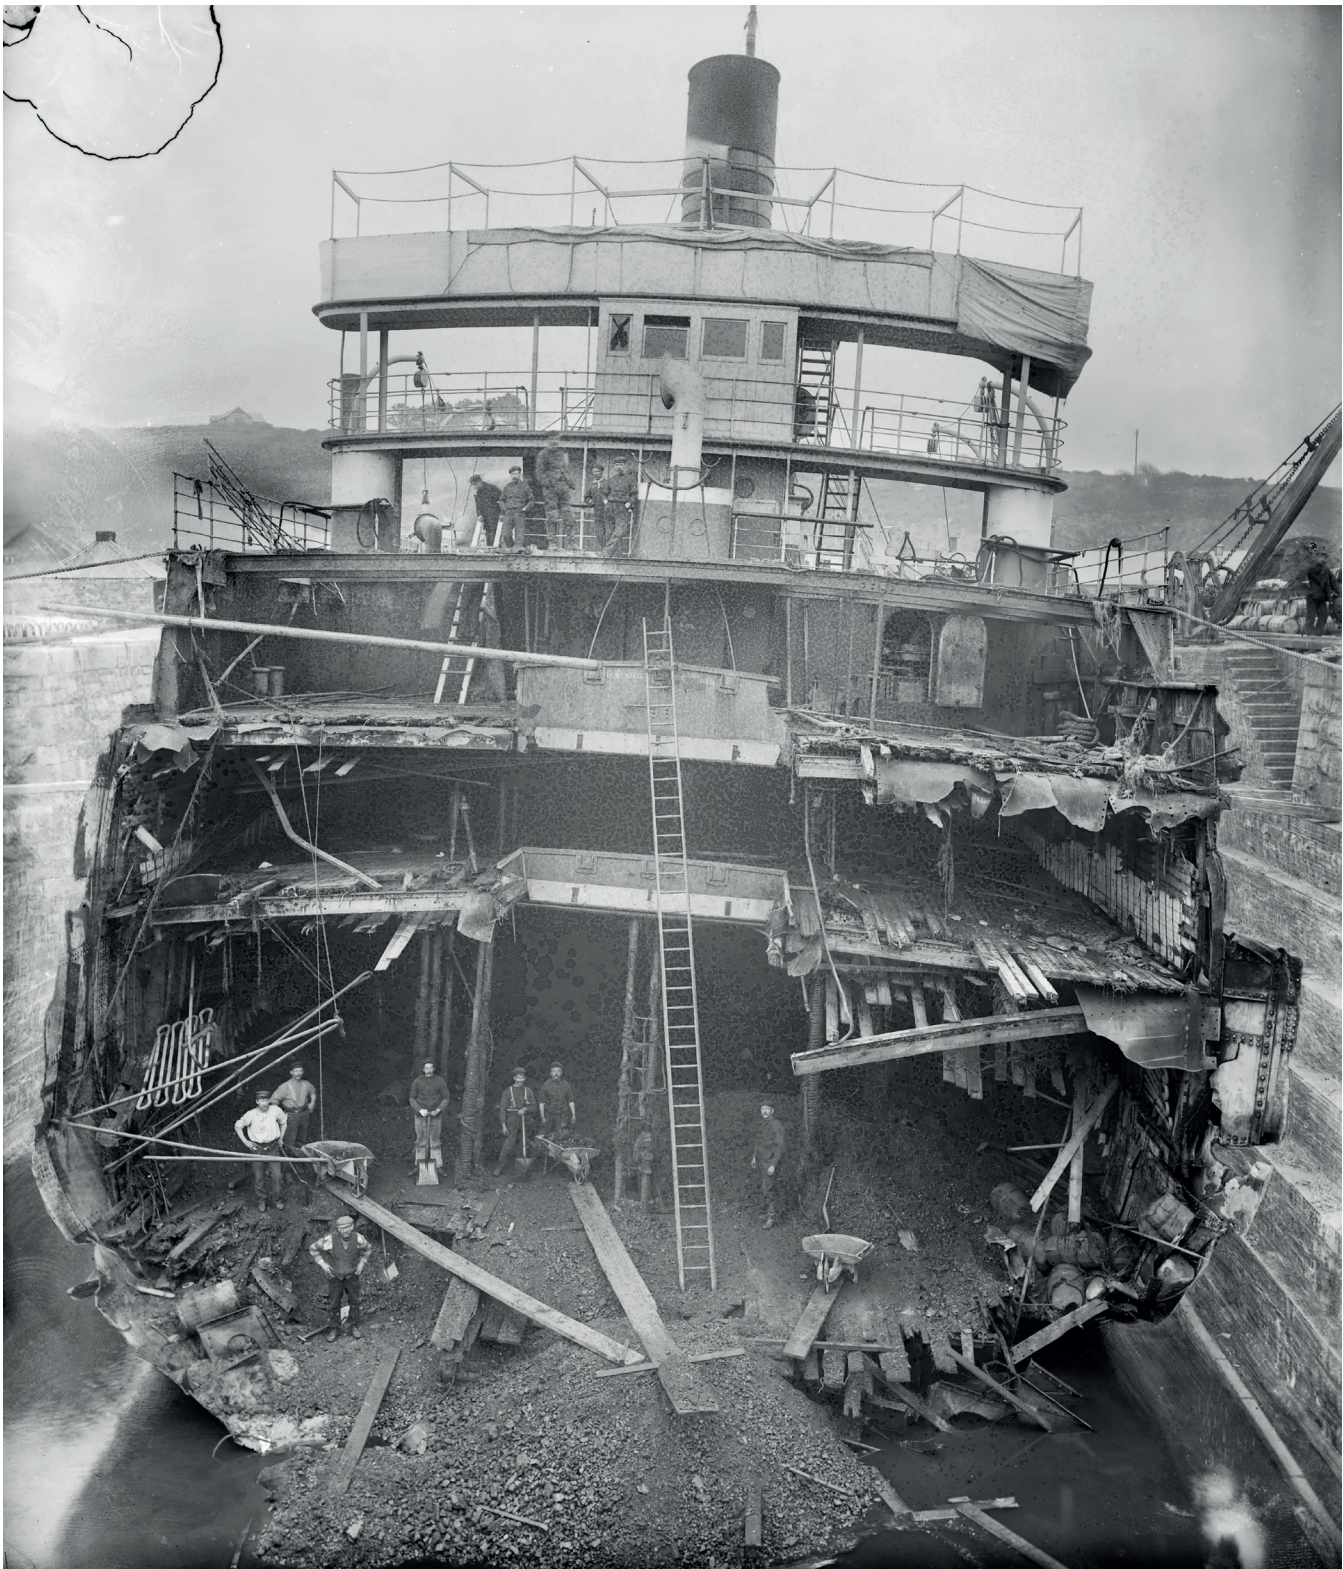
These are not the remains of the cement cargo the ship was transporting to South America, which was packaged into barrels, some of which are still visible. What the labourers are removing is in fact the ship's ballast.⁵

Fig. 02
A rare image of a precious resource:
dead weight.

The word ‘ballast’ is used almost exclusively as a metaphor today. But ballast was an integral part of seafaring. Its purpose was to lower a ship’s centre of gravity and to stabilise it at sea. This was done by loading cheap and heavy materials like sand, small stones and rubble into a ship’s hold, which lowered its waterline and reduced its tendency to pitch and roll. As ships travelled to the farthest corners of the globe, they carried ballast from and to ports all over the world. Ships needed the most ballast when they were running empty, but even fully loaded ships carried it. Especially during the winter months, shipmasters took care to load additional ballast. Looking at ships of similar size and displacement, the *Highland Fling* (which sailed in January) would have easily carried between 200 and 500 tonnes of sand and stones as ballast.⁶
